Maryland Inventory of Historic Properties Number: AL-VI-B-334

Name: MD 36 over Elklick Run

MARYLAND INVENTORY OF HISTORIC BRIDGES
HISTORIC BRIDGE INVENTORY
MARYLAND STATE HIGHWAY ADMINISTRATION/
MARYLAND HISTORICAL TRUST

SHA Bridge No. 1011 Bridge name MD 36 over Elklick Run

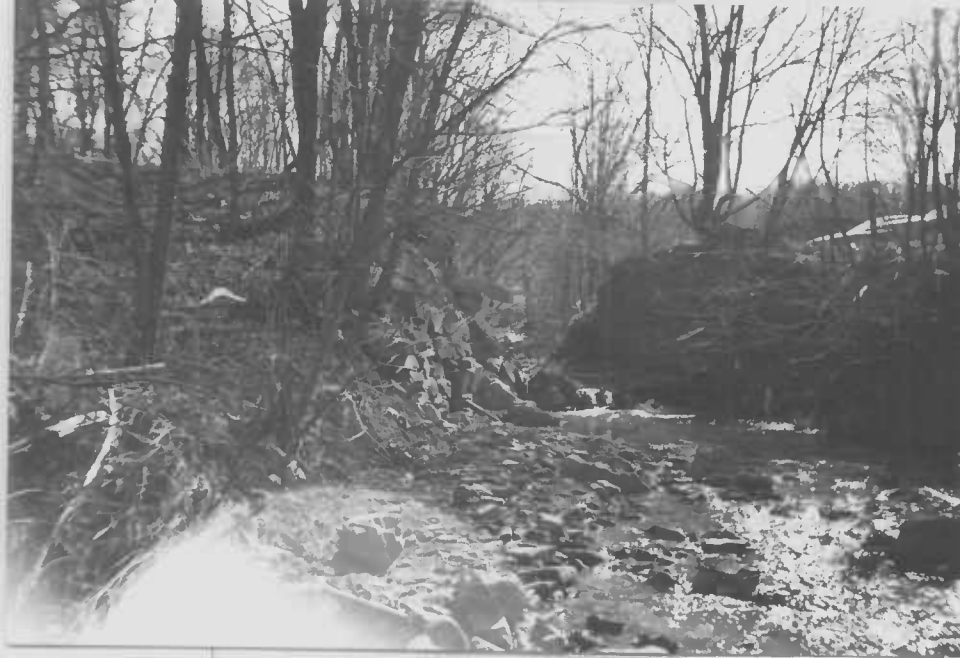
1. AL-VI-B-334
2. MO 36 over Elklick Run
3. Allegany Co. MO
4. Ryan McKay
5. 3/97
6. MD SHPO
7. Earlier Bridge Abutment
8. 3 of 6

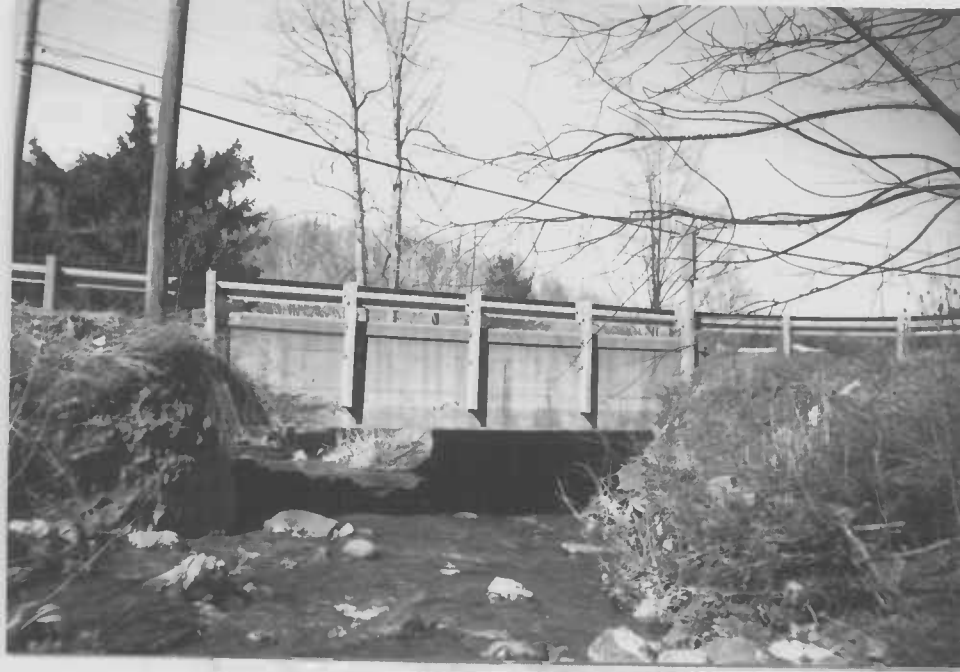
- 1 AL-VI-B-334
- 2 MD 36 over Elklick Run
- 3 Allegany Co, MD
- 4 Ryan McCay
- 5 3/97
- 6 MD SHPO
- 7 - Upstream elevation
- 8 4 of 6

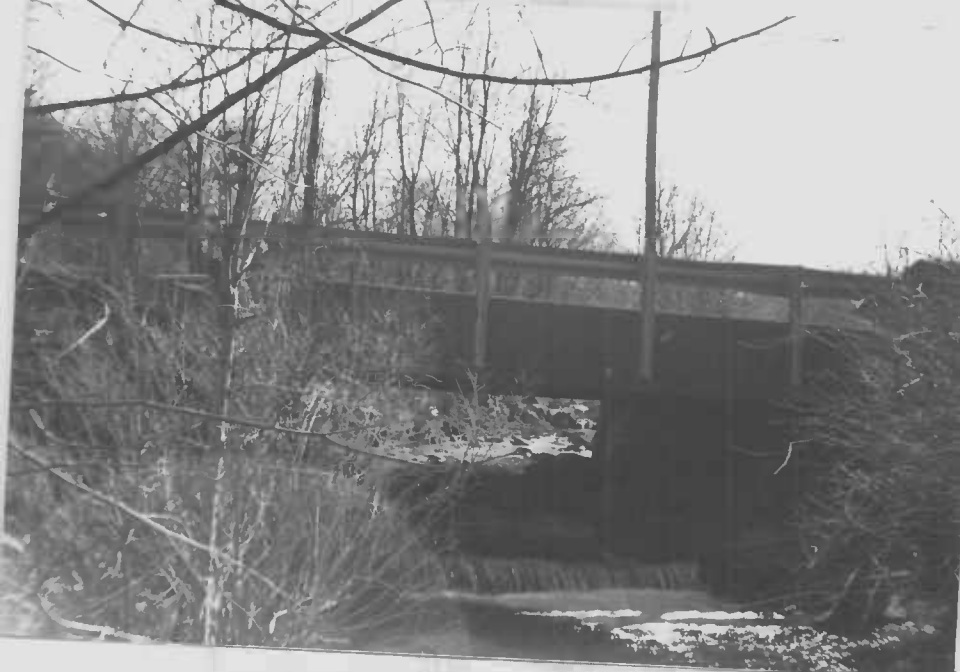
8. 10+6

7. Low stream elevation

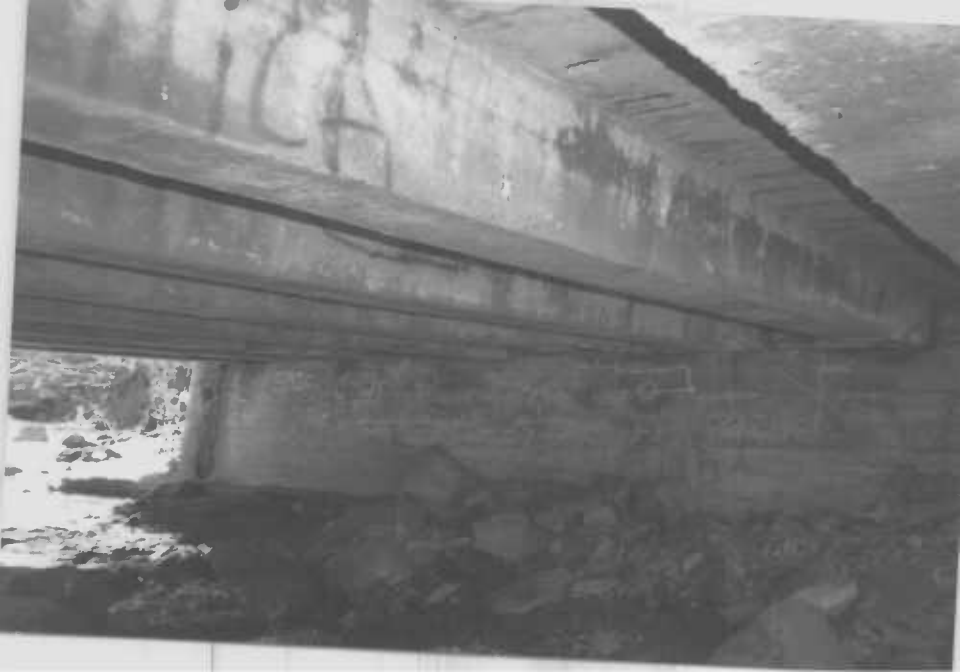
1. AL-VI-B-334
2. MD 36 over EIKlick Run
3. Allegany Co. MD
4. Ryan McKay
5. 3-97
6. MD SHPD
7. Detail of Beam
8. 2 of 6

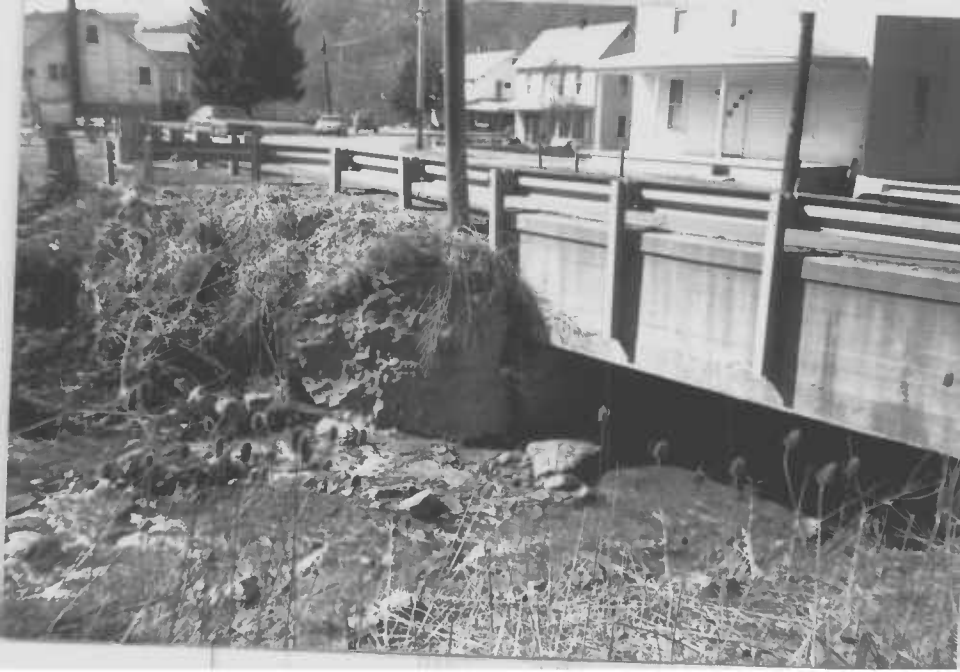
1. AL-VI-B-334
2. MD 36 over Elklick Run
3. ALLEGANY Co MO
4. Ryan McKay
5. 3-97
6. MD SHPD
7. Detail of SW wing wall
8. 5 of 6

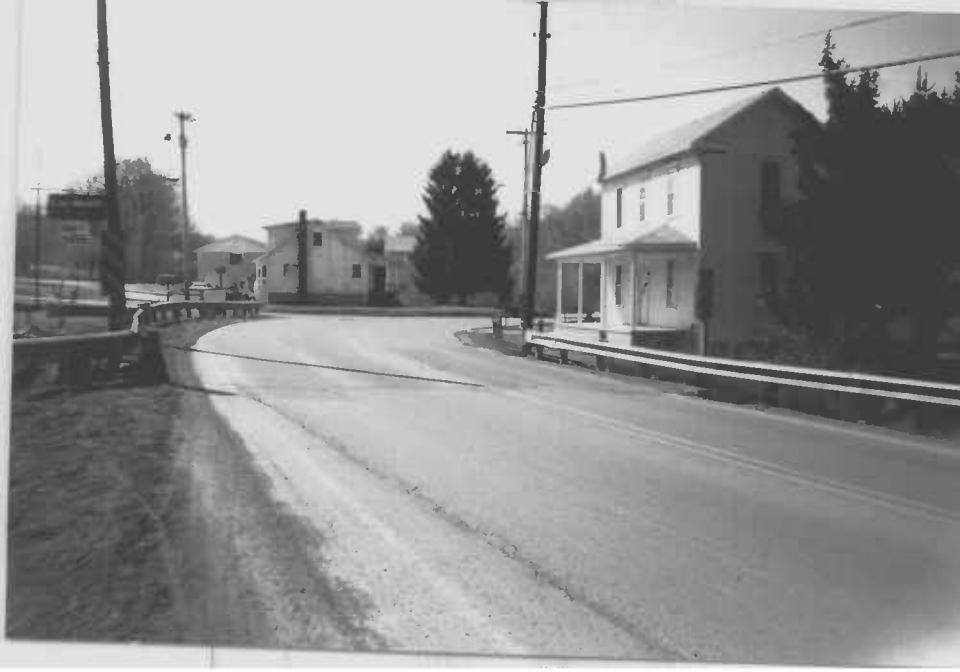
1. WAL- VI-B-334
2. MD 36 over EIRICK Run
3. Allegany Co. MD
4. Ryan McKay
5. 3-97
6. MD SH PD
7. East approach
8. 60+ 6
